**SAS Superstructure**

Daily Diary Report by Bid Item

Contract No.: 04-0120F4

**04-0120F4
04-SF-80-13.2/13.9
Self-Anchored
Suspension Bridge****Weather**

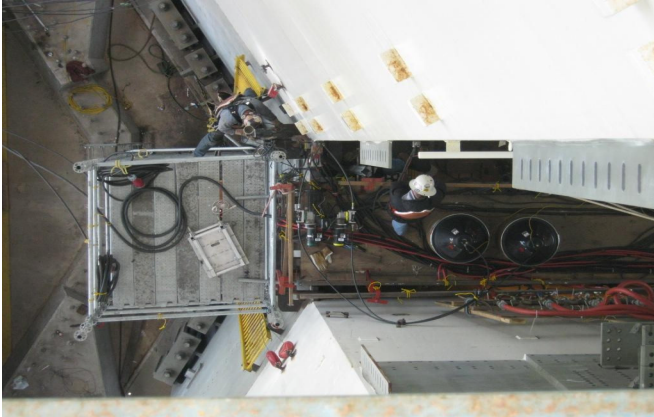
Looking down at the ESW weld in progress

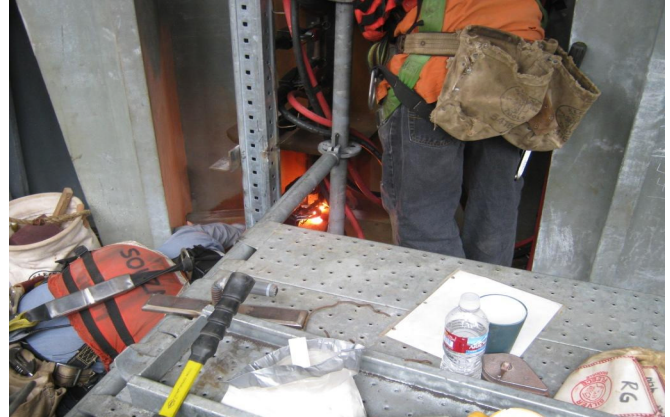
- At 08:33, the weld was started.
- It took about 2 minutes, 45 seconds for the weld parameters to stabilize.
- There was a small leak of weld metal from the starting sump. - See attached photo.
- At 10:37, the weld was low on flux and was running a little loud for about 1 minute.
- At 12:29, the weld was low on flux and was running a little loud for about 1 minute.
- At 13:06, the weld was ended in the run-off tab.

Small weld metal leak from the starting sump
